Manhole Inspection Summary

Manhole # S43KK_050MH

Insp Date: **8/13/08 11:01 AM**

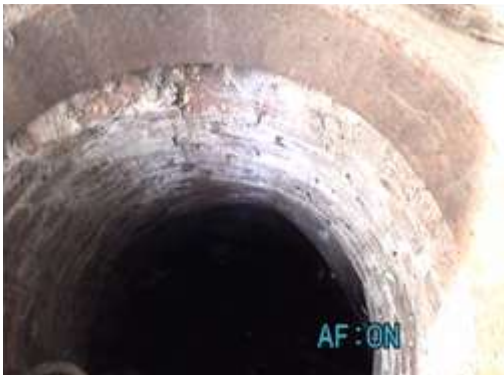
Defect 1

Infiltration: ☐ None ☐ Joint ☐ Cracks ☒ **Mortar** ☐ Roots ☐ Wall

Infiltration: ☐ None ☐ Joint ☐ Cracks ☐ Mortar ☐ Roots ☒ **Wall**

Infiltration

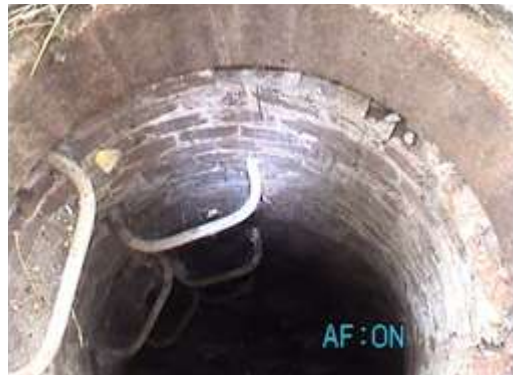
Defect 2

Frame Offset: **2** (in.) Condition: ☐ Sound ☐ Cracked ☒ **Leaks**

Frame leaks
